**KORDON TERMITE BARRIER**

renovation - detail 1

kd 045

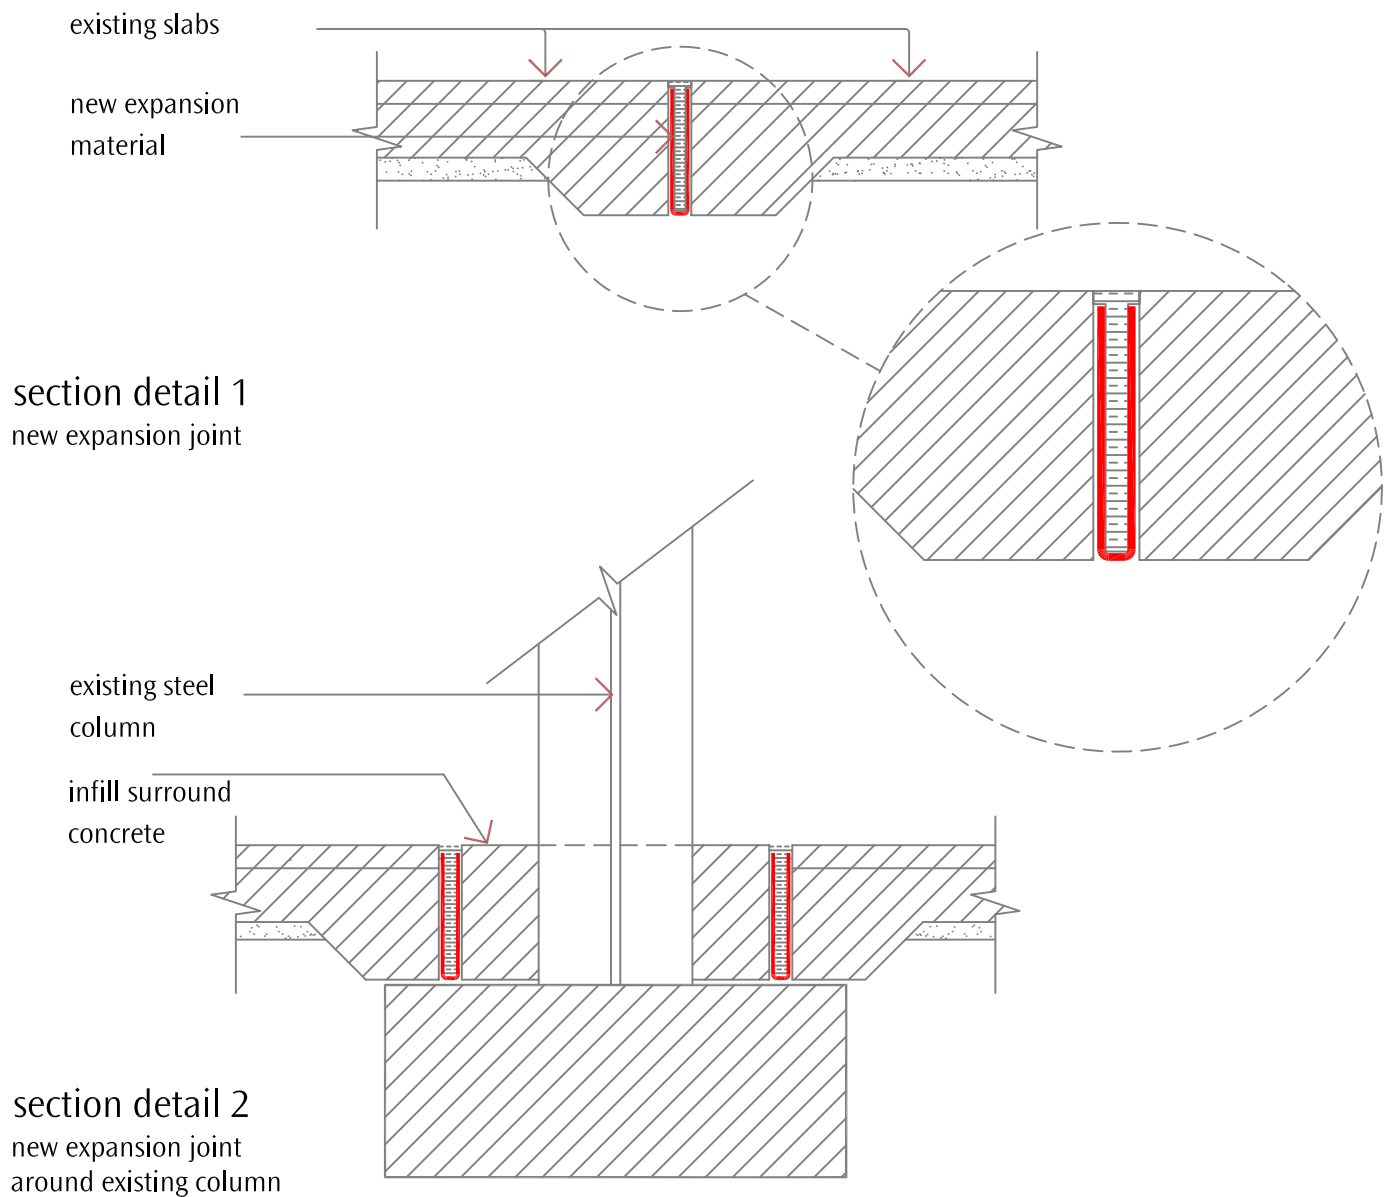
sketch below shows a existing slab floor to a factory
the expansion material has deteriorated over time and in need of
replacing.

It was suggested that in replacing the expansion material Kordon TB
could be installed to assist the pervention of concealed termite entry
