**kd045**

Subject:

**Renovation detail 1**

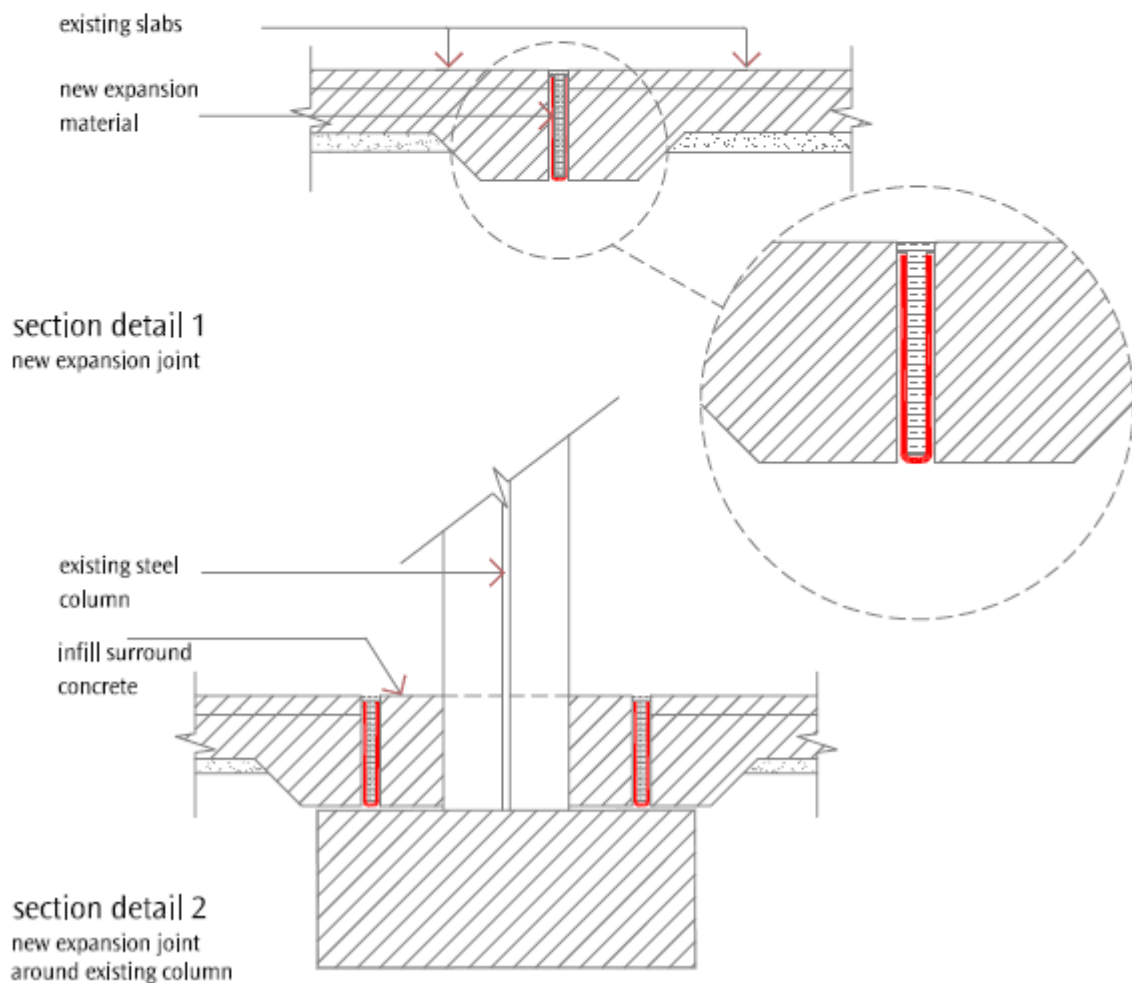
sketch below shows a existing slab floor to a factory  
the expansion material has deteriorated over time and in need of  
replacing.  
It was suggested that in replacing the expansion material Kordon TB  
could be installed to assist the pervention of concealed termite entry
