**KORDON TERMITE BARRIER**

retaining wall - photos

kd 028

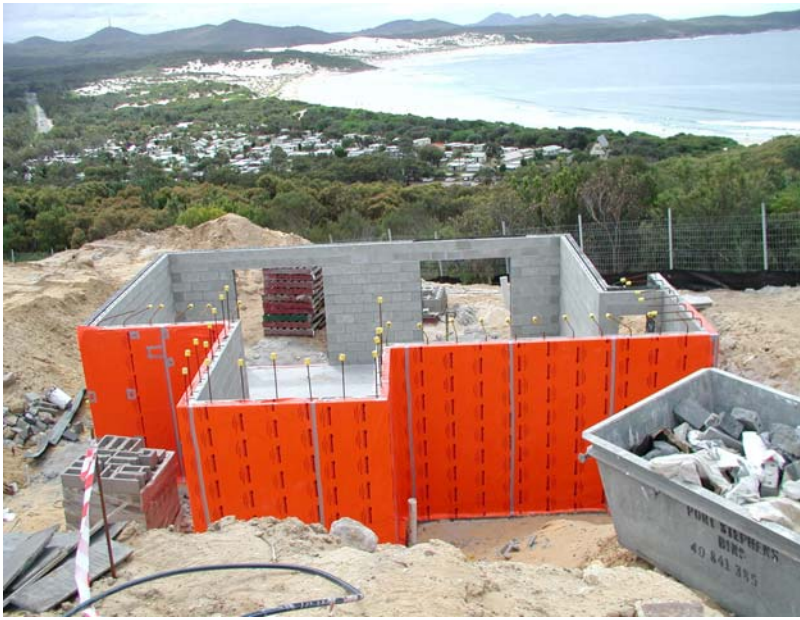
Photo 1
Kordon TB - full retaining wall

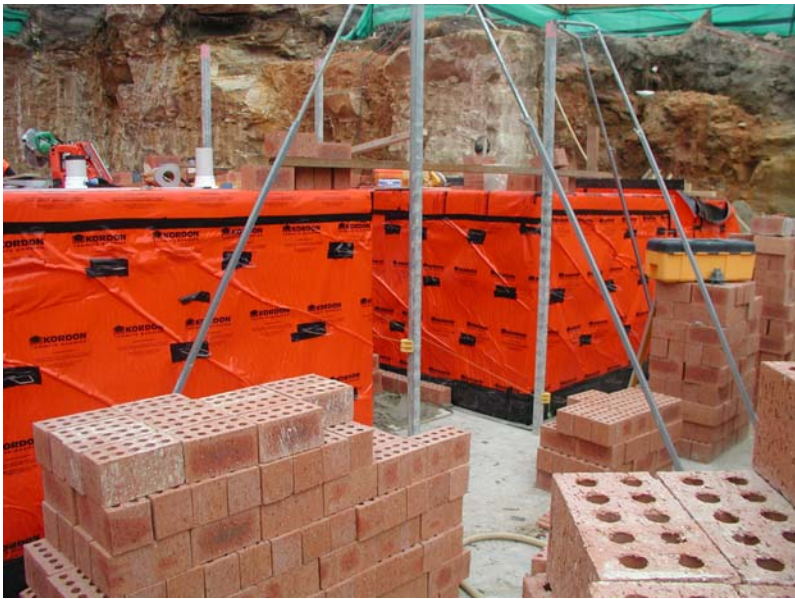
Photo 2
Kordon TB - retaining/stepdown

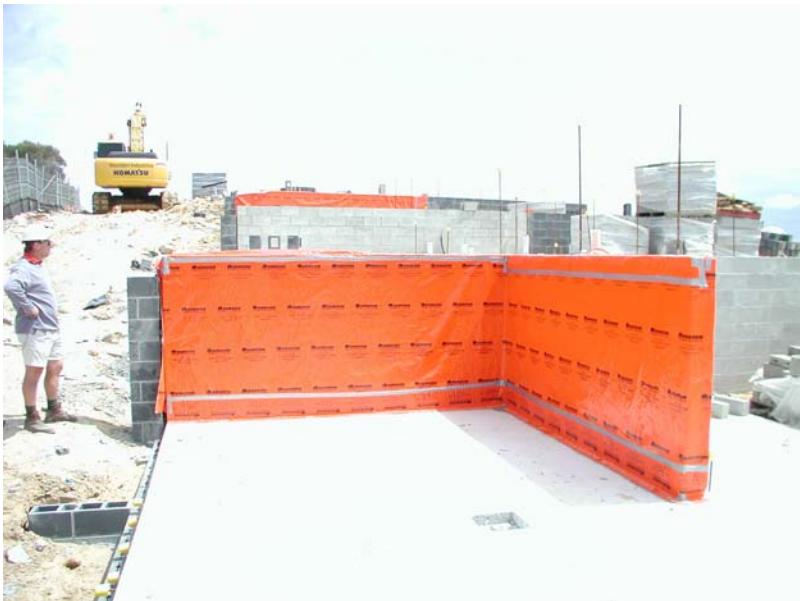
Photo 3
Kordon TB - internal wall treated
