**KORDON TERMITE BARRIER**

Bayer Environmental Science

new extension to existing wall

kd 029

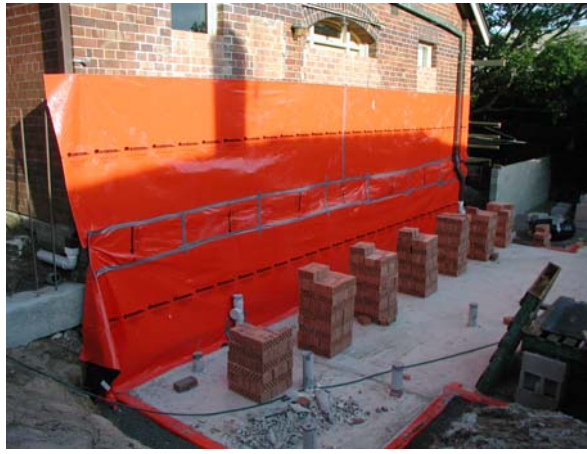
photo 1
showing existing structure
with Kordon TB secured
as per sketch
