**KORDON TERMITE BARRIER**

**door / sill - detail 3**

**kd 048f**

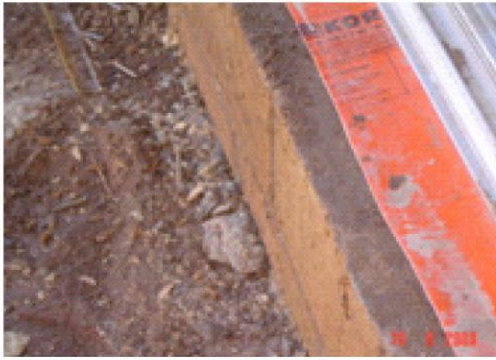
### Photo 1

shows Kordon cut back from brick face to allow secure fixing

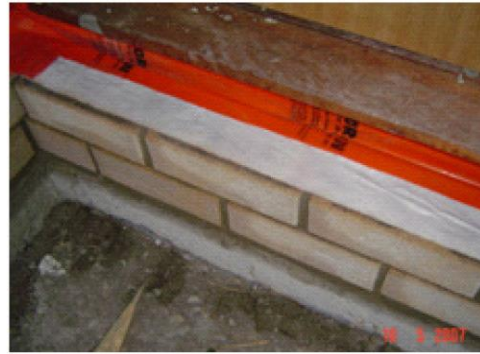
### Photo 2 (option)

shows Kordon orange plastic cut back brick face to allow secure fixing

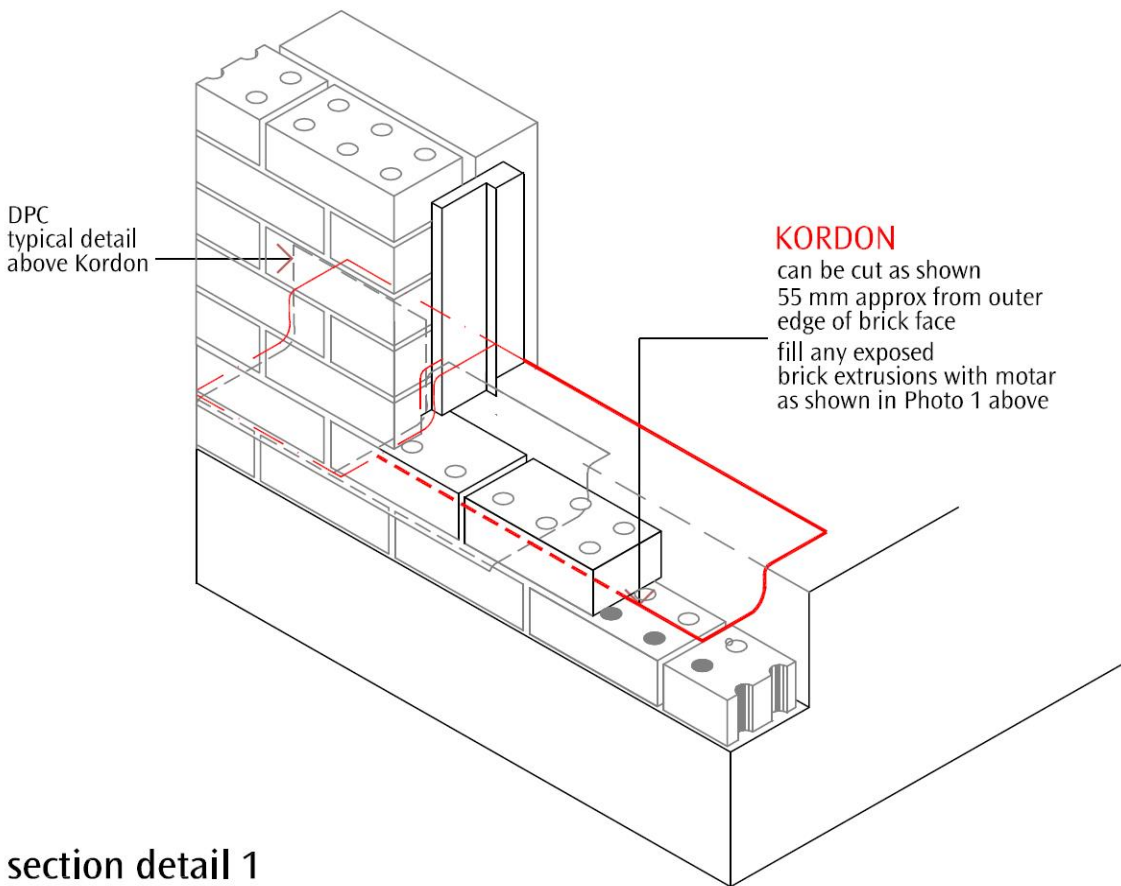
### section detail 1

typical wall opening at 2 brick rebate construction
