**Kordon®**

**kd 048f**

**Door Sill – Detail 3**

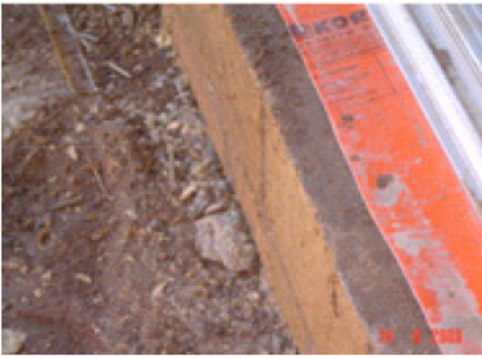
**Photo 1**

shows Kordon cut back from brick face to allow secure fixing

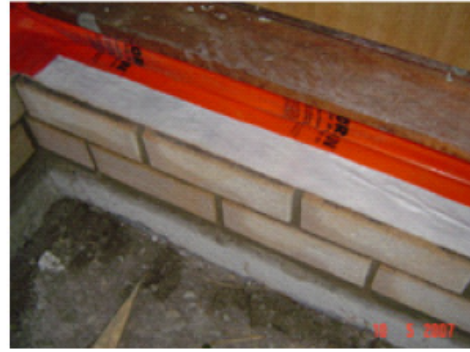
**Photo 2 (option)**

shows Kordon orange plastic cut back brick face to allow secure fixing

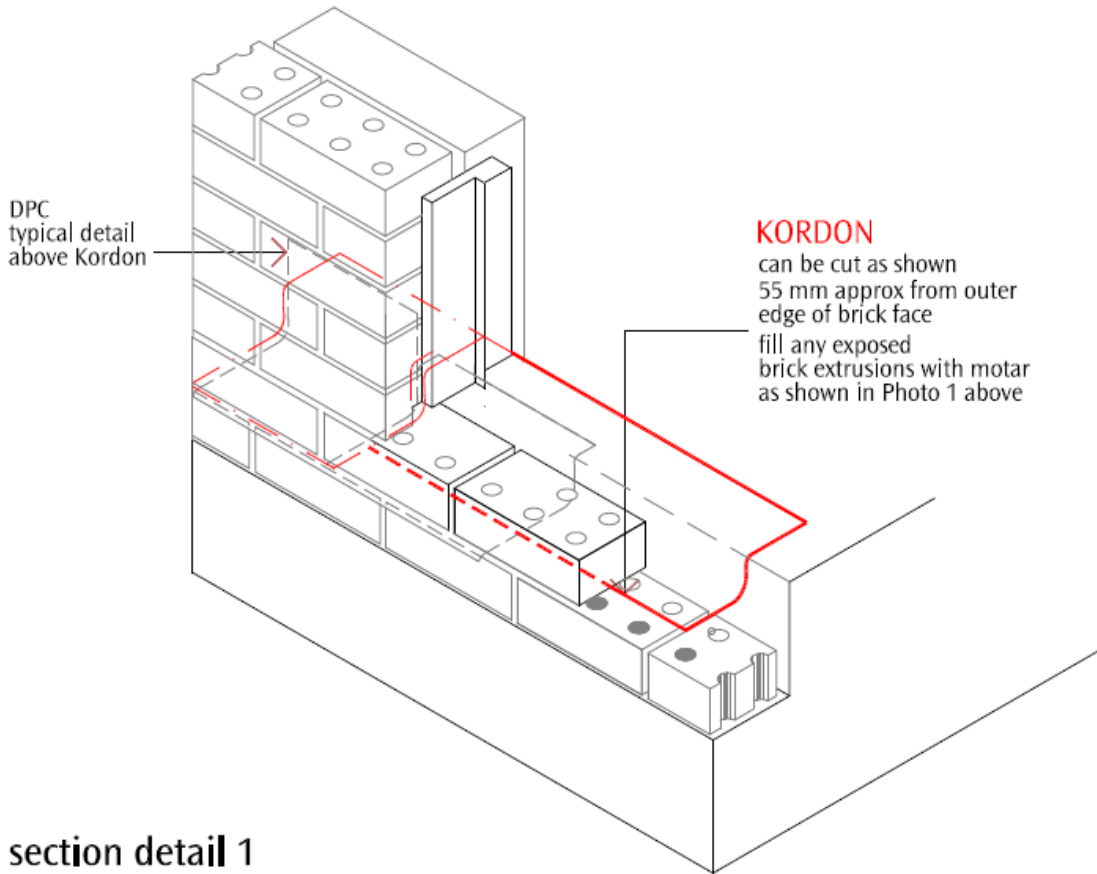
**section detail 1**

typical wall opening at 2 brick rebate construction
